**Project:** 090557-01

**Re:** Post-TCRA Quarterly Inspection Report - January 2013 Inspection

This document reports the results of the January 2013 quarterly inspection of the armored cap cover, fencing, and signage installed for the Time Critical Removal Action (TCRA) at the San Jacinto River Waste Pits Superfund Site (TCRA Site).

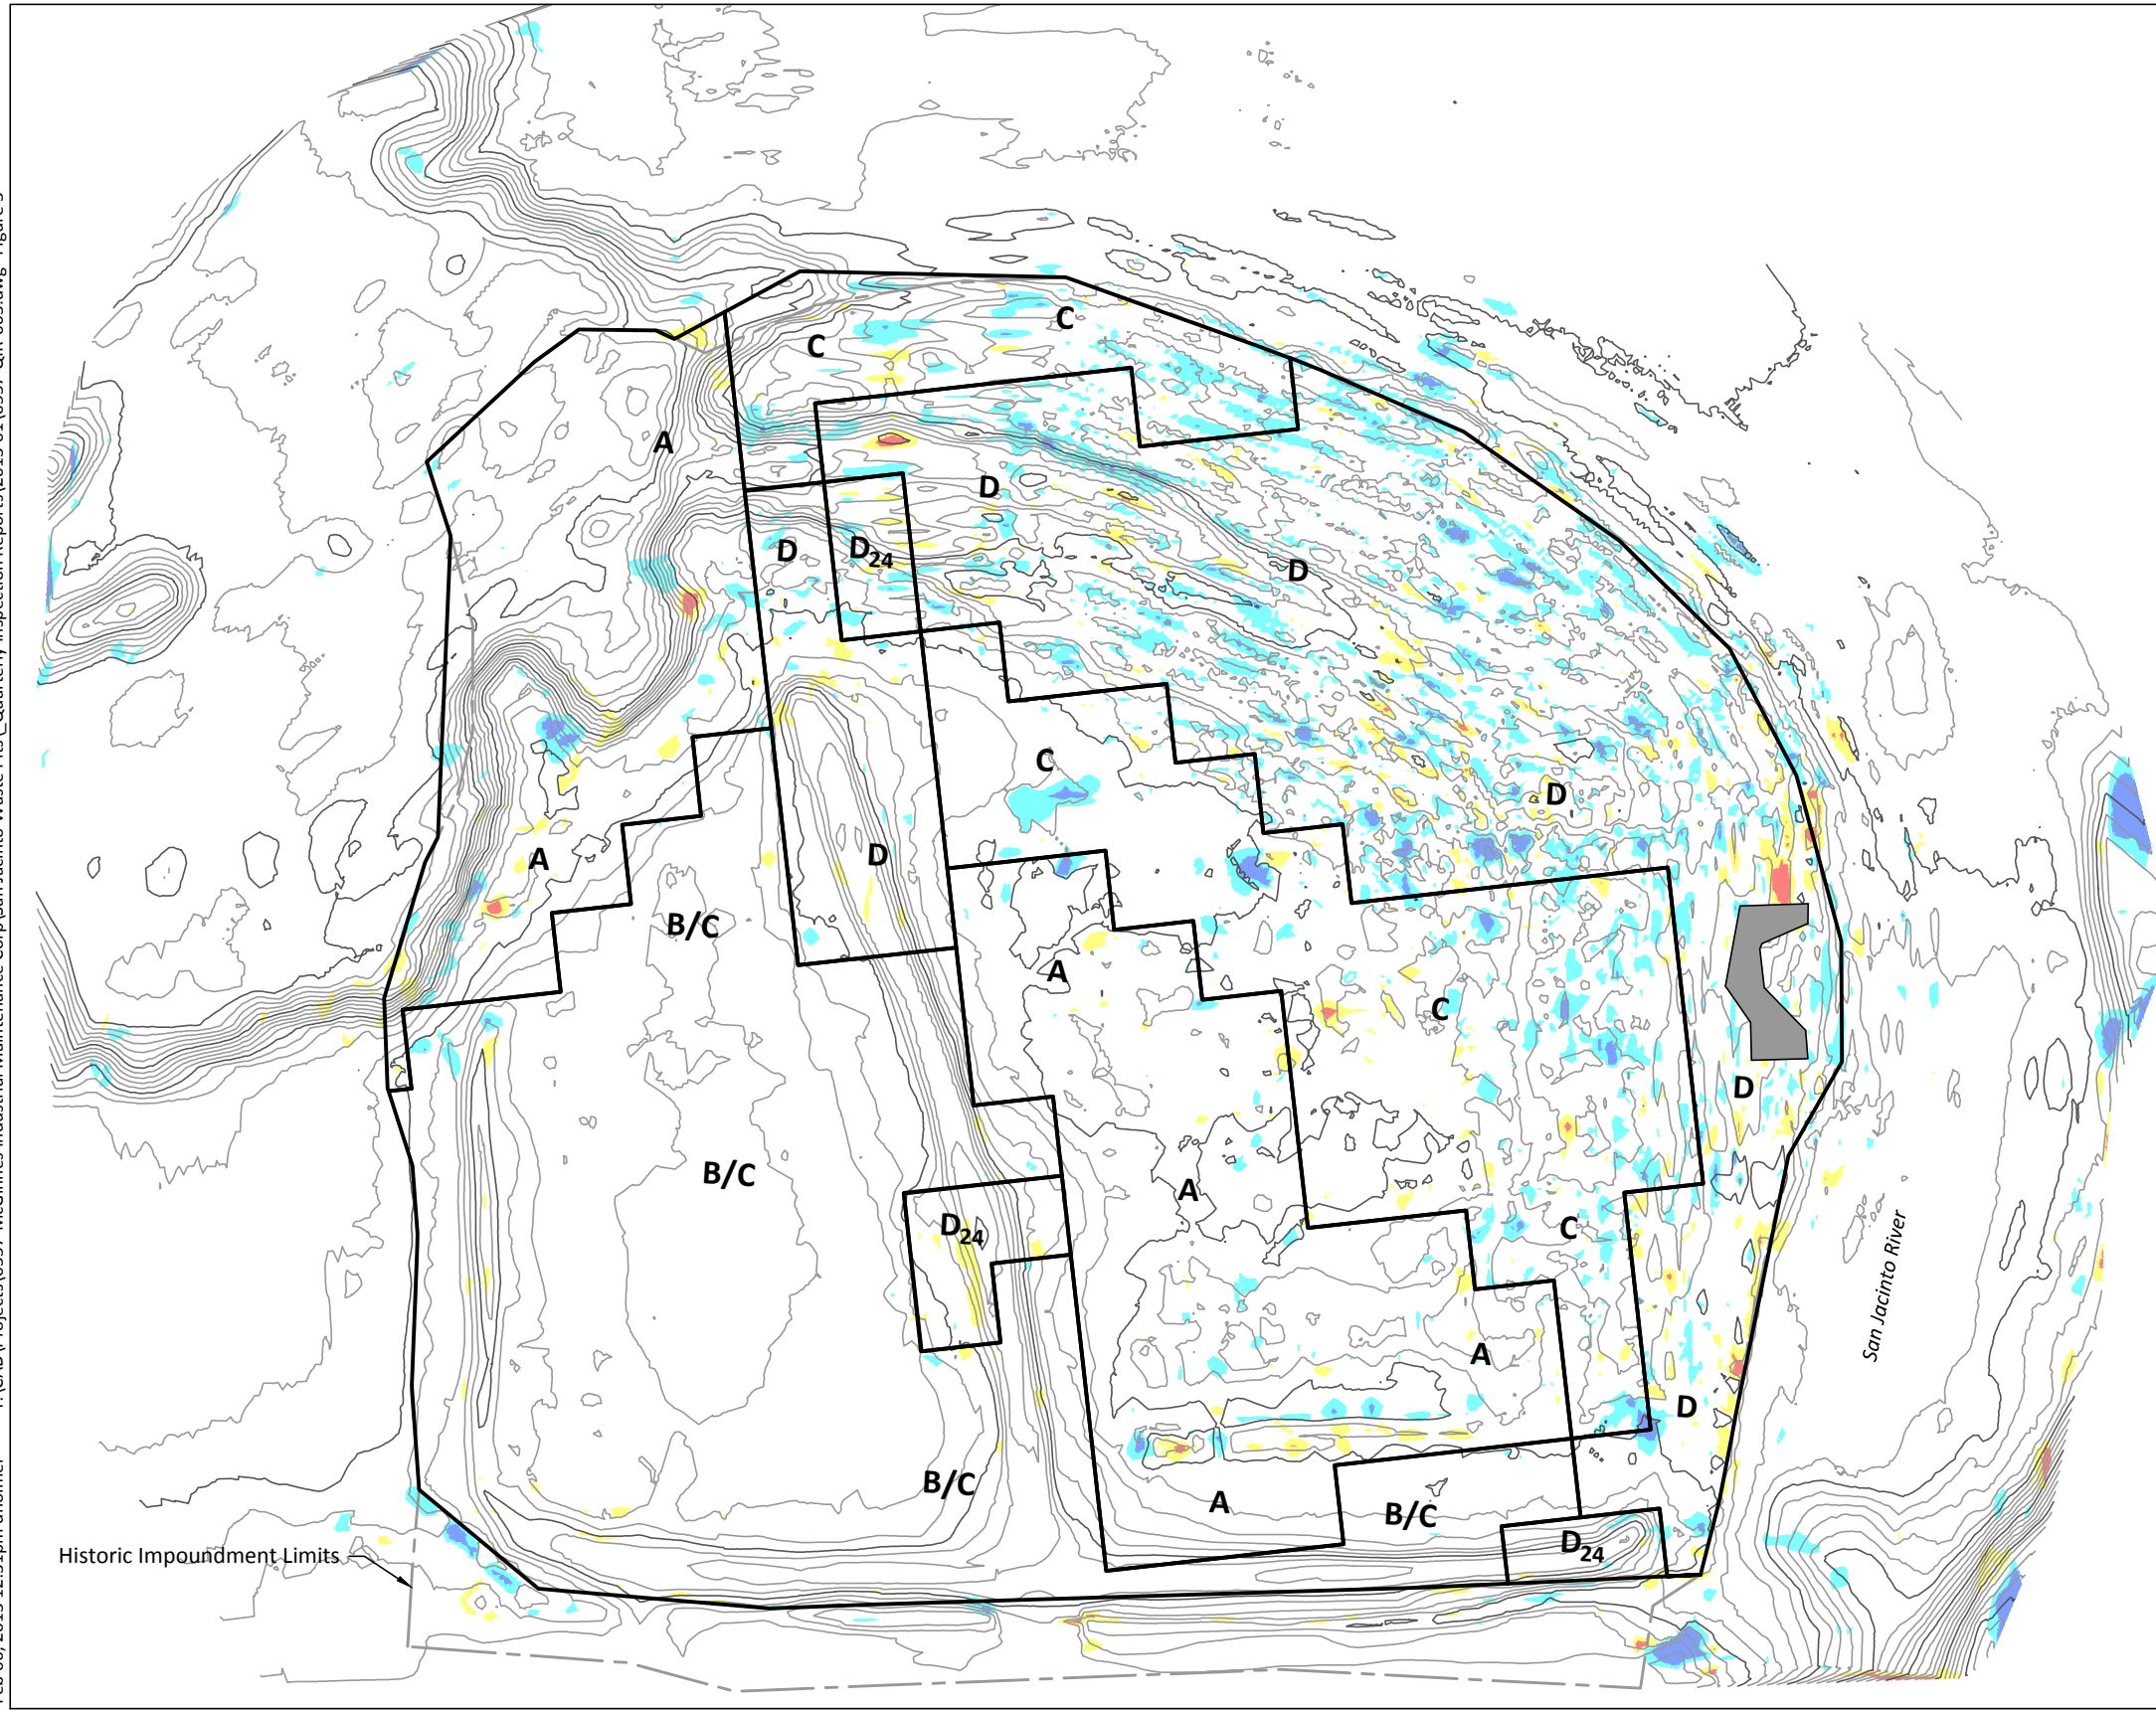
A small area in the intertidal zone was not safely accessible by either topographic or bathymetric methods (Figure 3). Seasonally low tides with north winds during the month of January prevented safe access by boat to the areas identified on Figure 3. Algal and crustacean growths in these small areas were hazardous for the surveyor to access by foot. Visual inspection in this area indicates that no movement of the armored cap has occurred in these areas.

The survey for this quarterly inspection event was conducted by Hydrographic Consultants, Ltd. Hydrographic survey data were collected from January 22, 2013 to January 28, 2013; upland topographic data were collected from January 3, 2013 to January 30, 2013. The topographic survey required additional days to complete in order to accommodate the maintenance event, and the hydrographic survey was offset as a result of the consistently low tide conditions at the TCRA Site during the month of January 2013. Figure 3 displays the results of the completed survey.

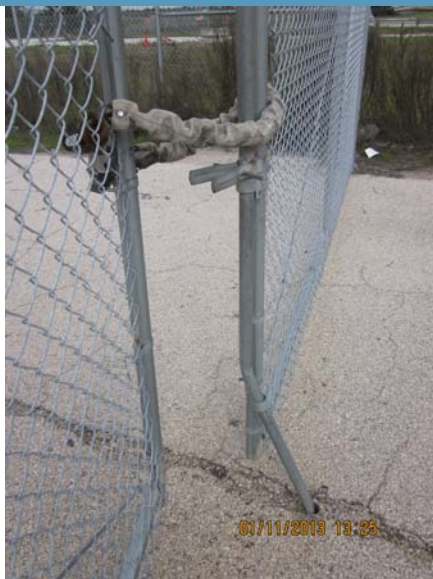
The visual inspection event on January 11, 2013 did not identify damaged or otherwise deficient areas in the perimeter fence or signage. Incidental damage to the fence center post at the eastern gate was noted, but did not require action, as it was not identified as a breach in the fencing. However, additional inspections of the TCRA Site fencing during the armored cap survey and maintenance event identified two breaches in the perimeter fence. These two areas were repaired by the Respondents' Fence Contractor; all repair activities were completed by February 6, 2013. Details regarding the TCRA Site fencing repairs are provided in the attached Maintenance Completion Report; see photographs 26 through 28 of Appendix A for examples of the fencing repairs.

Photo 05: Bent center post of east access gate (view east)

Photo 28: New gate center post installation, east bank (view north)

During the work day on January 30, 2013 a NFC representative examined the breaches in the perimeter fencing to develop plans for maintenance of the fence. Subsequently, two panels were repaired and three additional panels were reinforced. The east access gate center post was also replaced due to minor damage.

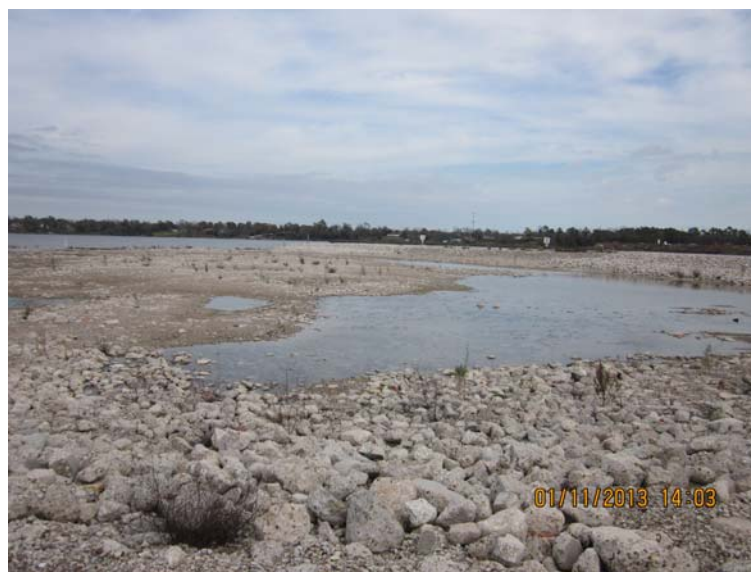
Photo 08: Interior of Western Cell with standing water (view northeast)

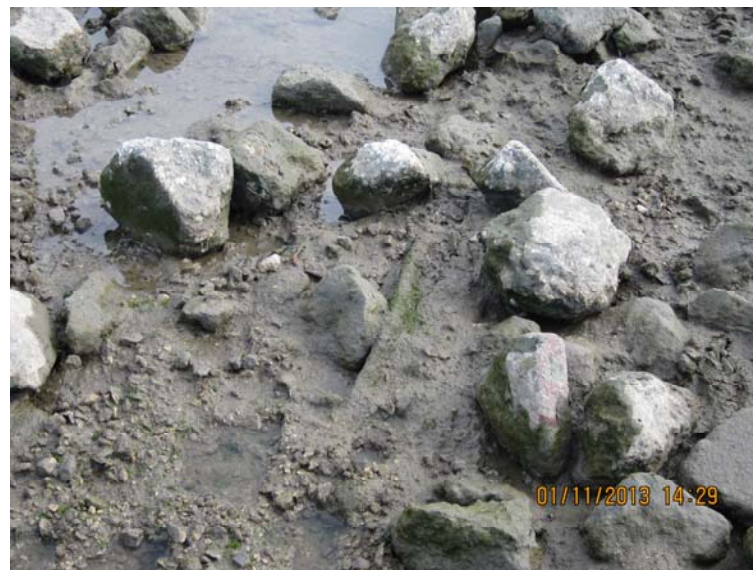
There was a low tide during the January 11, 2013 visual inspection because of northerly winds. This low tide exposed two localized areas of the TCRA armored cap cover with less than 12 inches of stone cover thickness. The underlying geotextile layer in those areas was intact and there was no evidence that any of the underlying materials were or had been exposed. The USEPA was notified of this condition through a phone conversation and submission of a notification letter on Tuesday, January 15, 2013. The Respondents conducted a field investigation during a low-tide event on Thursday, January 17, 2013 collecting topographic and probing data that identified three additional areas that had less than 12 inches of stone cover thickness and would require maintenance. One of the three additional areas also required geotextile placement over an approximate 2 foot by 2 foot area. Further phone communications with the USEPA took place on Thursday, January 17, 2013, and an additional written notification was submitted to USEPA on January 18, 2013. The Respondents continued to evaluate the TCRA cap during the low tide conditions that existed on January 17 and January 18, 2013. The low tide event on Friday, January 18, 2013 was the lowest of any of the inspection days, and was at -2 foot mean sea level (MSL)<sup>3</sup>.

Photo 12: Thin armor cap area identified during visual inspection (view north)

The areas in the Eastern Cell were characterized by reduced stone cover thickness or other conditions, as described in the TCRA Inspection Repair Report. While the maintenance work was being performed, one small area required some geotextile repair. The TCRA Site fencing deficiencies identified along the western bank of the San Jacinto River consisted of cut chain link and bent/mangled bottom sections. All maintenance activities for the TCRA armor stone layer and repair activities for the deficient areas of TCRA Site security fencing have been completed. These activities are detailed in the attached Maintenance Completion Report (Appendix B).

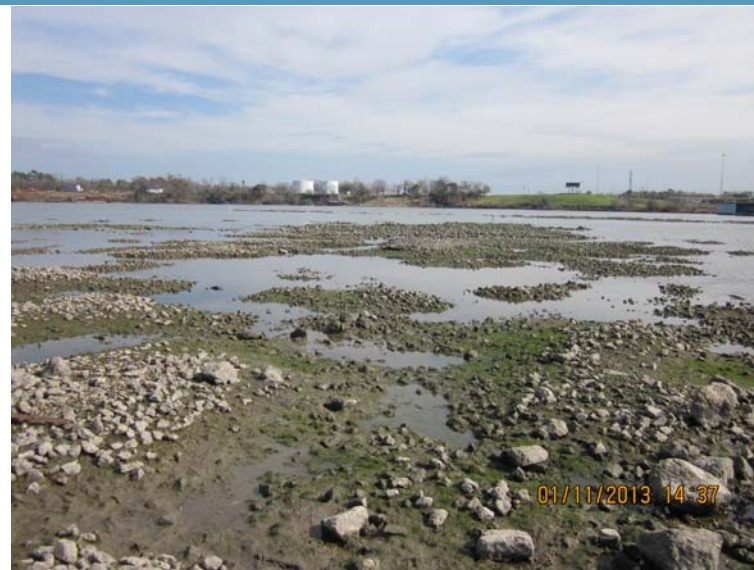
Photo 14: Low tide conditions in the Eastern Cell; note sedimentation and biological growth (view east)

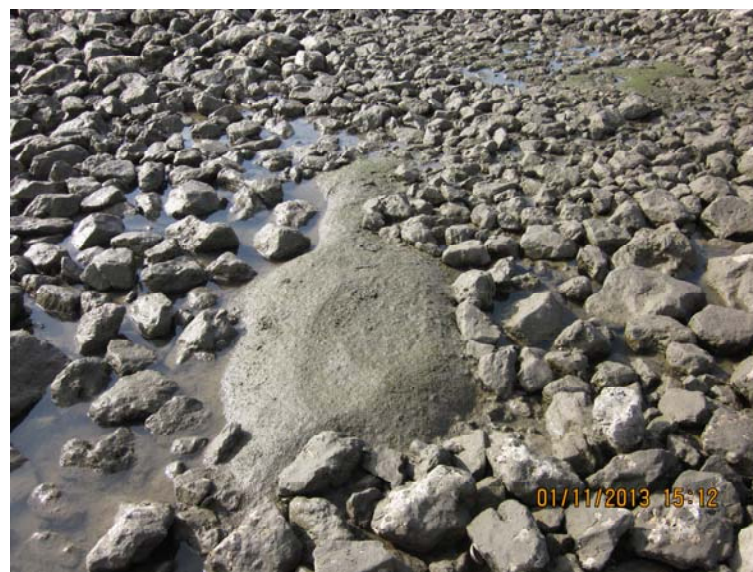
Photo 16: Areas (foreground and background) of thin armor cap area and exposed geotextile identified during visual inspection (view northwest)

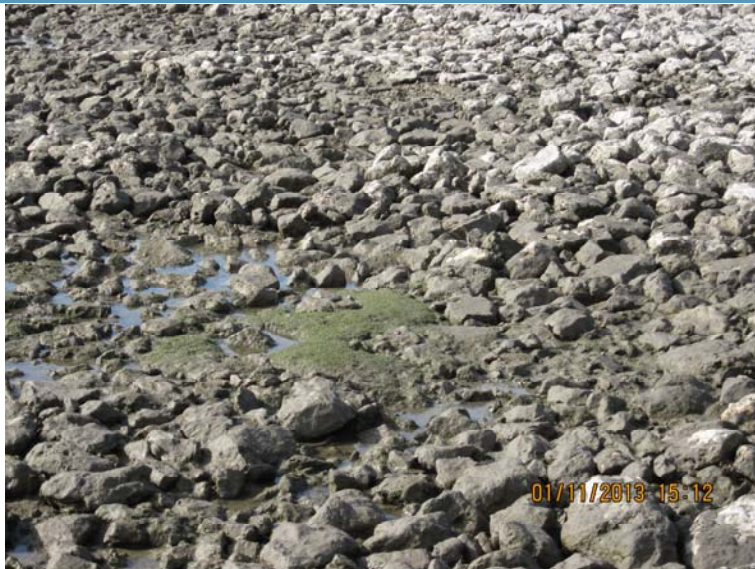
Photo 17: Background location from Photo 16 of thin armor cap area and exposed geotextile identified during visual inspection (view southwest)

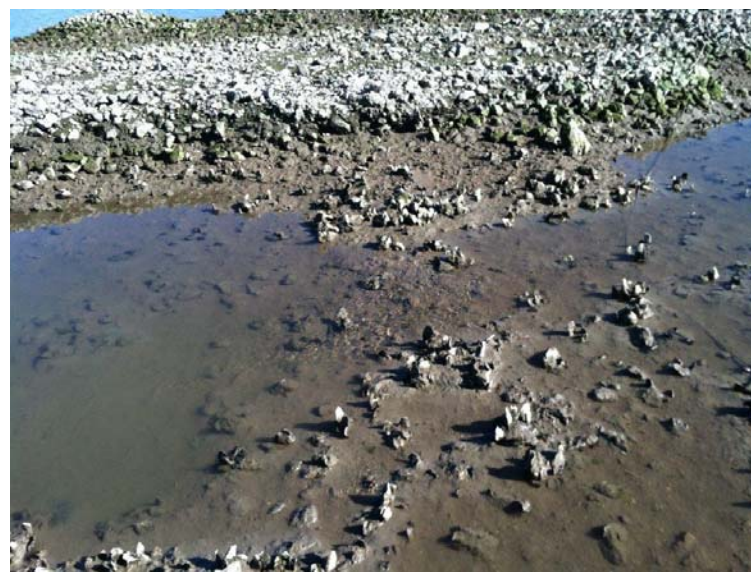
Photo 24: Area of Eastern Cell showing biologic growth and sediment deposition (view northeast)

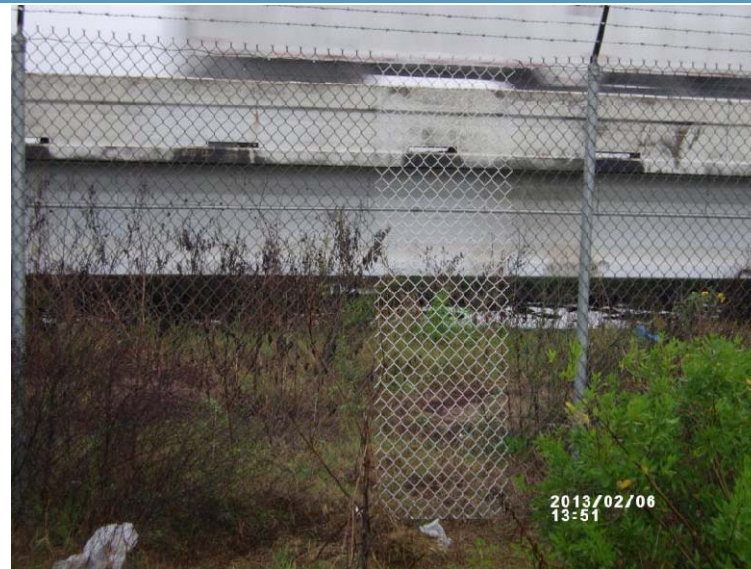
Photo 26: Repaired fence fabric, south alignment, west bank of the San Jacinto River I-10 crossing (view north)

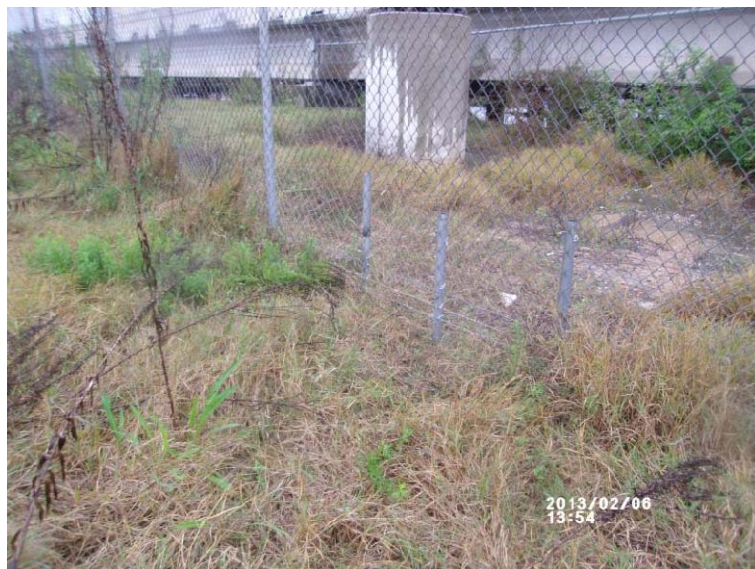
Photo 27: Added lower supports on adjacent panels to secure fence fabric and barb wire (view northwest)

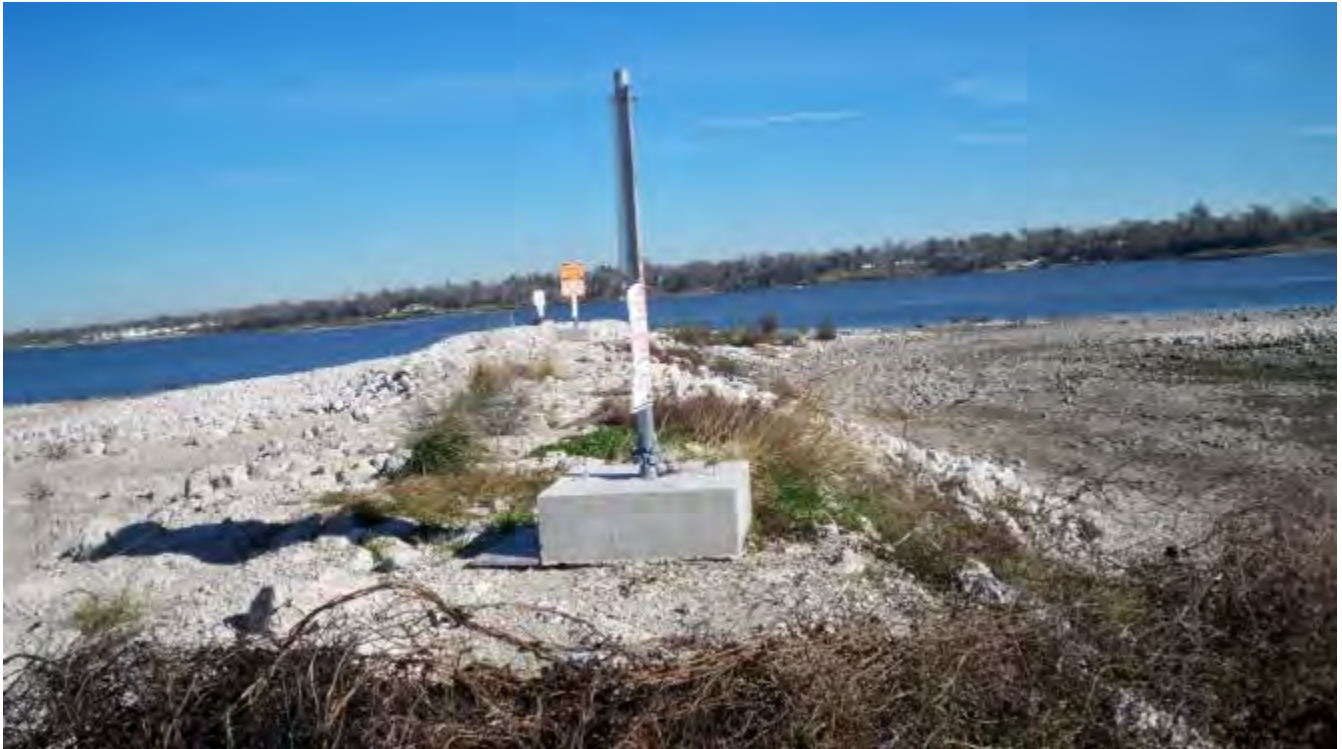
Photograph 2 – Vines removed from signage on central berm.

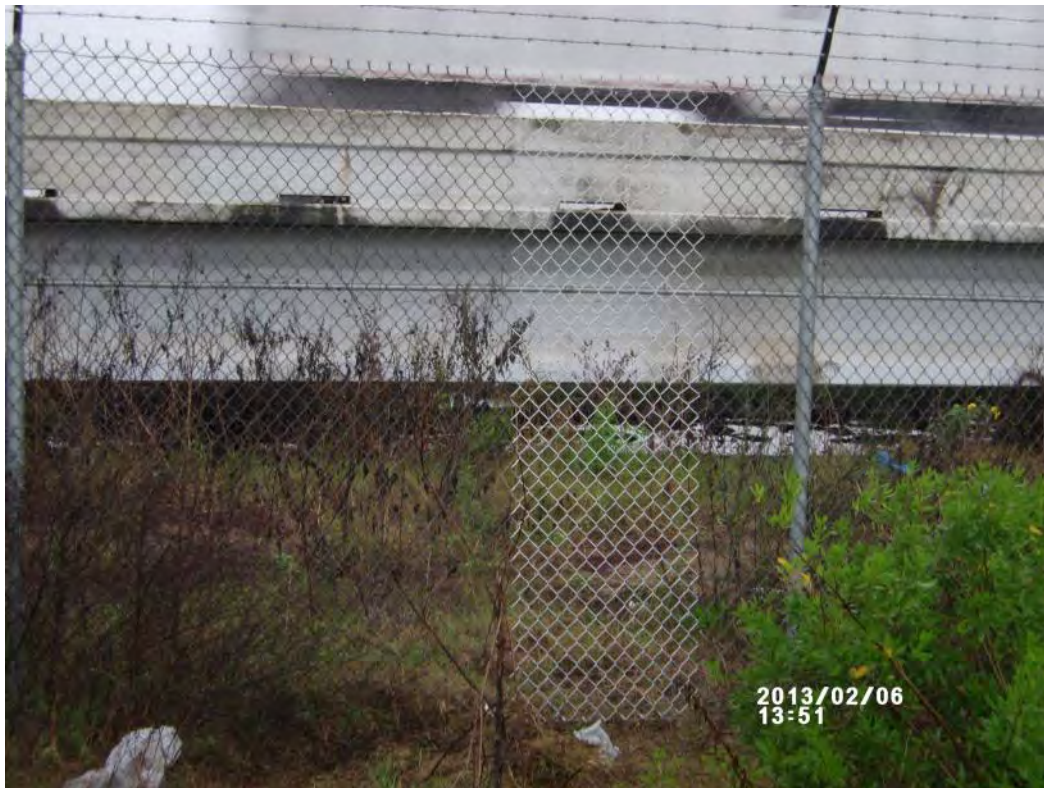
Photograph 1 – Repaired fence fabric, south alignment, west bank of the San Jacinto River I-10 crossing

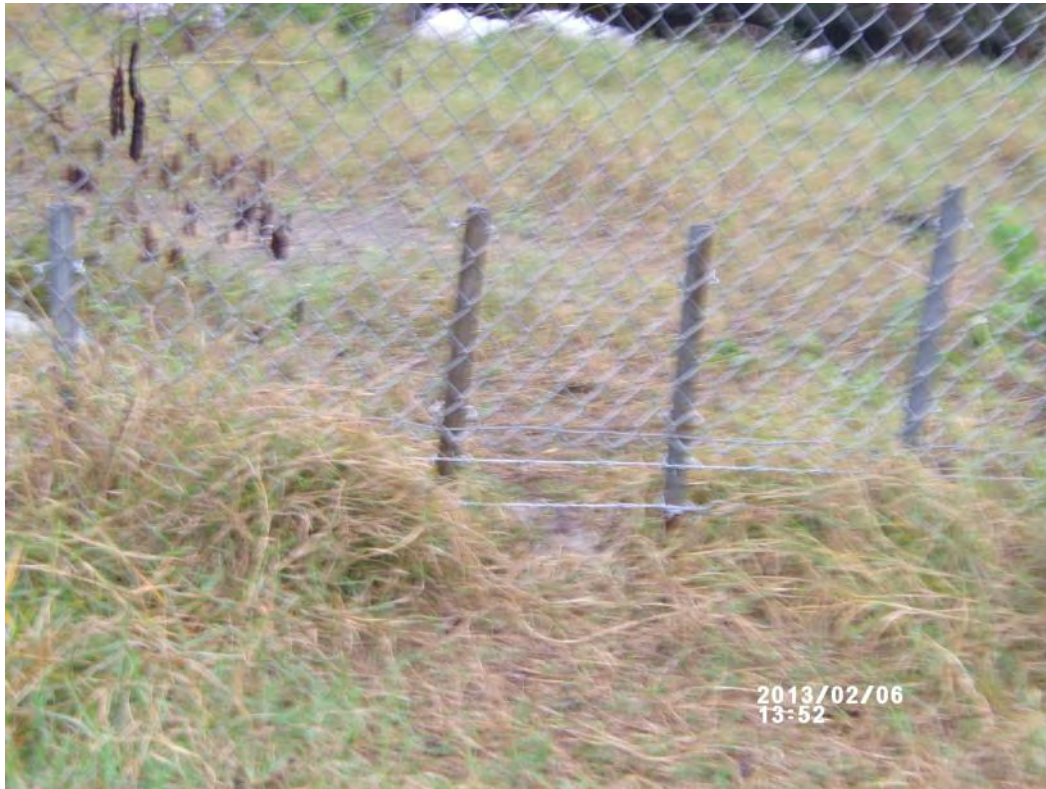
Photograph 2 – Added posts and barb wire closures, south fence alignment, west bank.

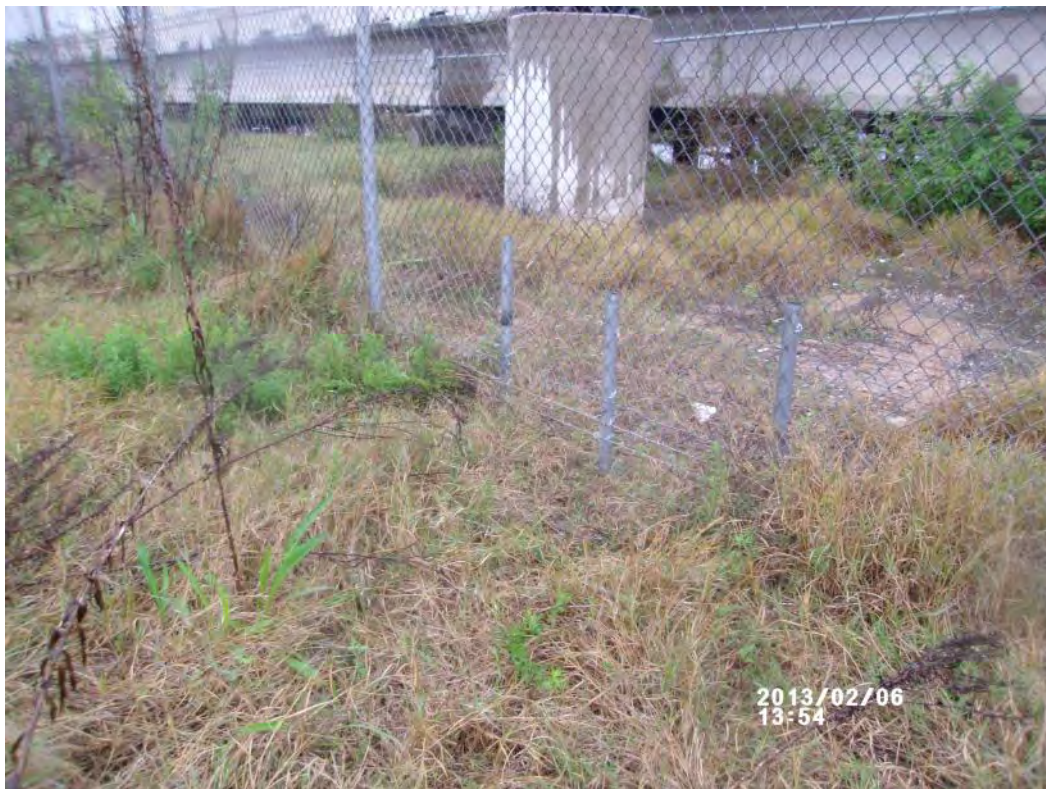
Photograph 3 – Added barb wire and fence supports to prevent access, south fence line, west bank.

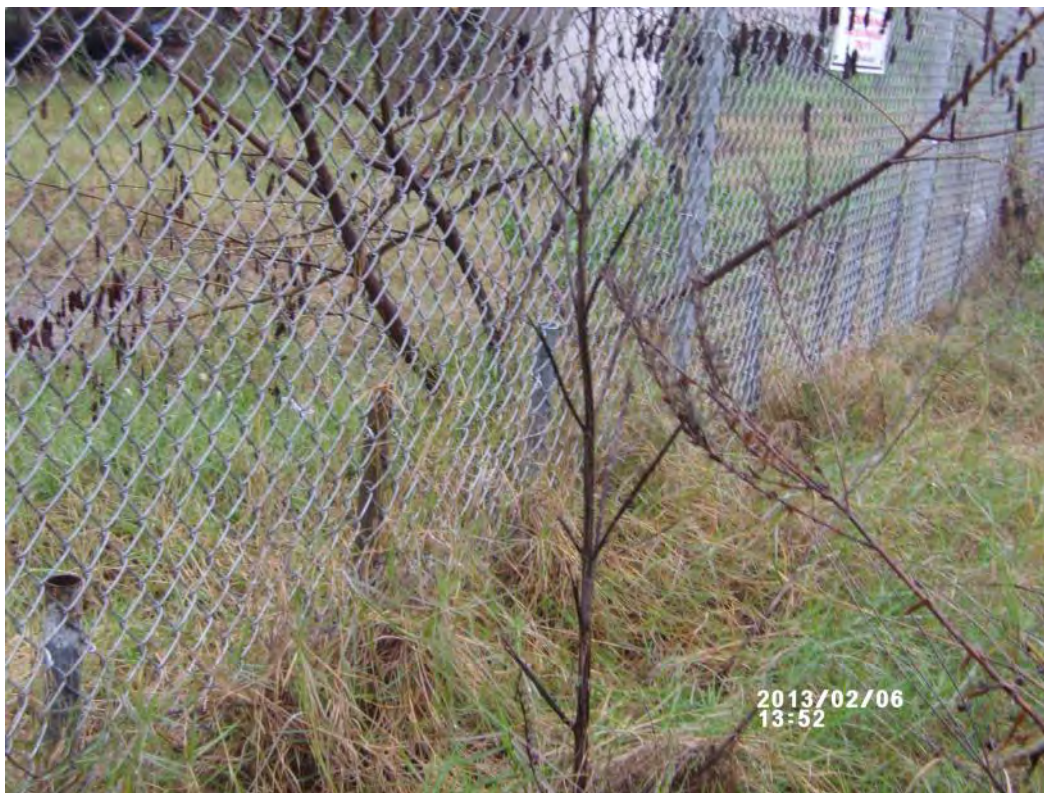
Photograph 4 – Added lower supports on adjacent panels to secure fence fabric and barb wire.

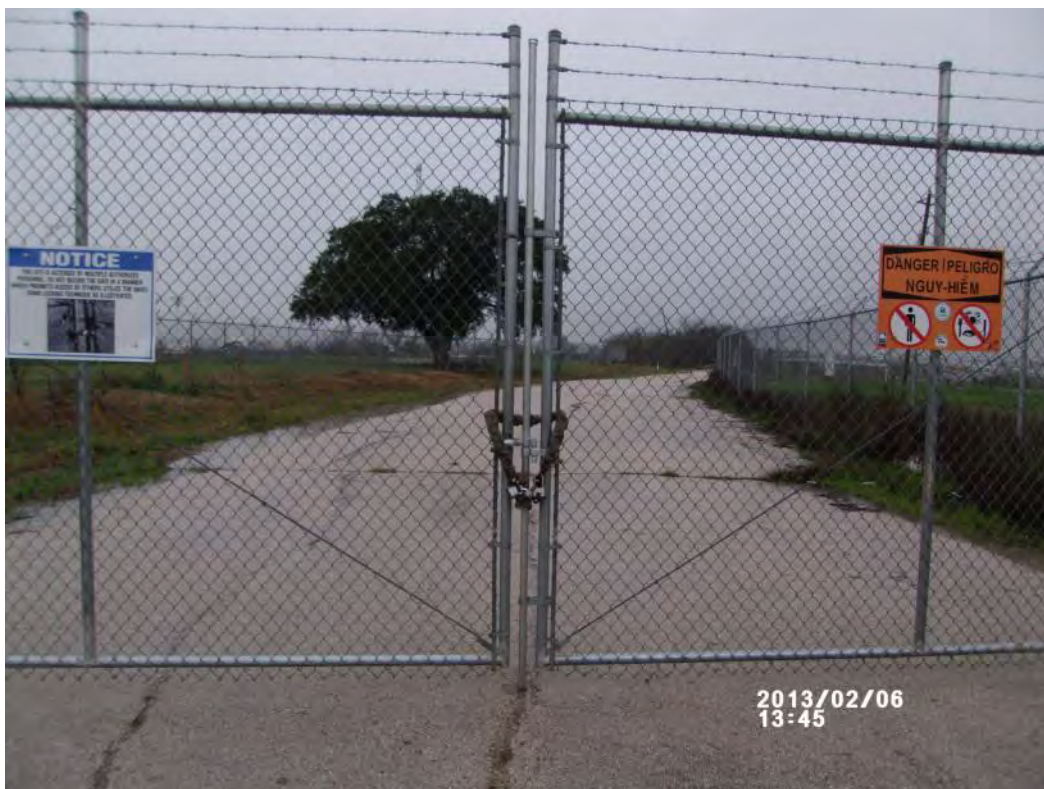
Photograph 5 – New gate center post installation, east bank. All fence maintenance actions complete.
